Site Name: GNB, Inc. CERCLIS ID No.: TXD007331879

Street Address: 1880 Valley View Lane City/State/Zip: Farmers Branch, TX 75234

Investigator: S. Bret Kendrick Agency/Organization: ICF Technology

Date: Feb. 1993

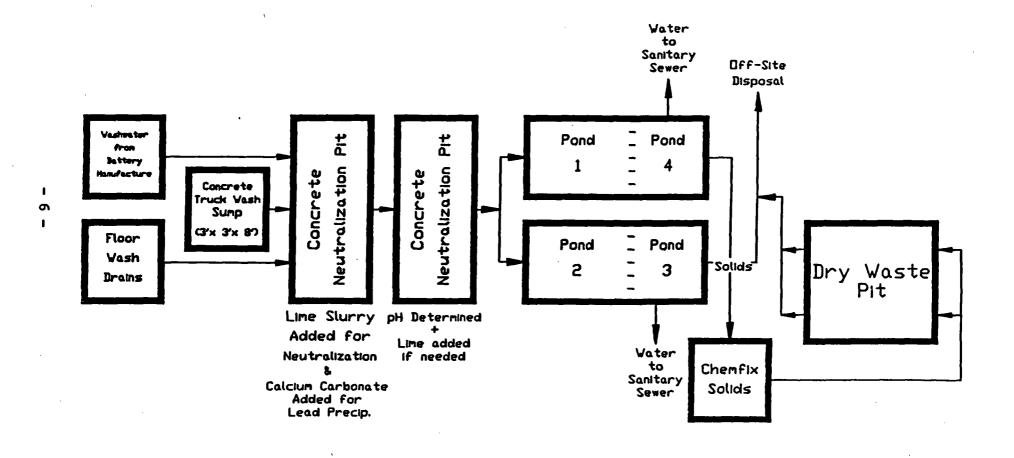
Figure 2: Process Flow Diagram (1972-1985)

As discussed above, the battery manufacturing process generates wastewaters that are acidic and contain lead. The facility has changed wastewater treatment practices twice since operations began [1, 2, 29]. A process flow diagram from 1971 (beginning of operation) until May 1985 is shown in Figure 2 [1]. The facility then changed operations, as shown in Figure 3 [2]. These operations ran from May 1985 until March 1986. The facility then switched to their current process which is shown in Figure 4 [29].

Mittelhauser Corporation August 1987 Prior to 1985, acidic wastewater containing EP toxic levels of lead from the battery manufacturing process, floor wash drains, and truck wash sump (SWMU 2) was fed to the first of two concrete pits (SWMUs 3 and 4) in which treatment occurred [1, 2]. Lime and calcium carbonate were added to raise the pH to a suitable level for optimum precipitation of lead hydroxide [2]. The lime was added by means of flexible hoses. The discharge from the first pit went to a second pit where additional lime was added and the pH was adjusted. The discharge from the second pit fed one of two lagoons (SWMUs 5 and 7). Each lagoon was composed of two ponds (SWMUs 5 and 6, SWMUs 7 and 8). Solids were allowed to settle in the ponds and the effluent water was sent to the sanitary sewer.

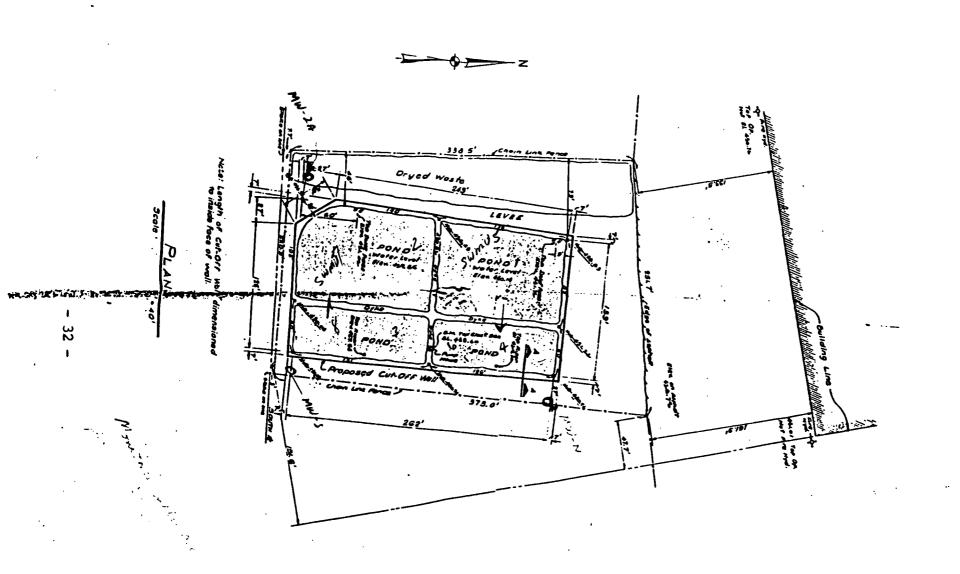
Figure 6: Detail of four ponds

Since approximately May 22, 1985, the ponds have not been used due to a change in the disposal process at the GNB facility. Prior to this change, Ponds 1 and 2 received treated wastewater from the neutralization pits. The slurry resulted from the neutralization of sulfuric acid and contained high levels of lead. The solids contained within the slurry were allowed to settle to the bottom of the pond, and the wastewater flowed into Ponds 3 and 4 from where it was eventually discharged into the sanitary sewer. The sludge was then retrieved and chemically fixed on site (at least until 1982). The fixed materials were retained in the disposal pit prior to eventual off-site disposal.

The sludge ponds began operation on May 15, 1972 [8]. Both installation of liners and a slurry wall were recommended during the early 1970's. The facility chose to only install the slurry wall which, according to company letters, was completed on May 28, 1976. The integrity of this wall is in question because ground water contamination has been detected in company installed monitoring wells outside the slurry wall. A 2 foot concrete main connecting some of the ponds with a drainage channel located off company property also existed. However, according to the facility, this channel is left over from when Morton Foods owned the property and has been plugged since operation of the ponds by Inc. began. The drainage channel discharges into the Gould. Trinity River. There are also low areas in the vicinity that could accept surface run-off from this pond had it ever occurred.

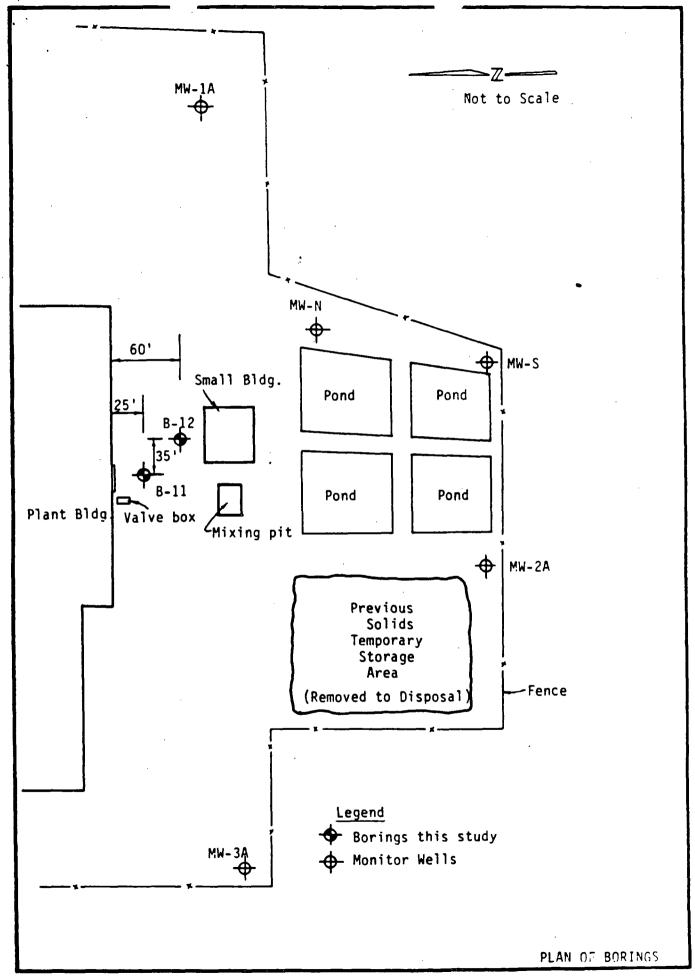
# LOG OF BORING NO. 8-11

BURIED EFFLUENT PIPELINE GNB BATTERIES, INC. PLANT FARMERS BRANCH TEXAS

LOCATION: See Plan of Borings, Plate 1 TYPE BORING: Undisturbed Sample
